Our reference: **FOI20/23**

### **DECISION ON YOUR ACCESS APPLICATION**

*“Engineering reports for Building 1:*

1. *Canberra Hospital Building 1 - Facade Inspection Report (2020 Update) - Issue 02*
2. *Canberra Hospital Building 1 - Facade Inspection Report (2020 Update) - Appendix A*

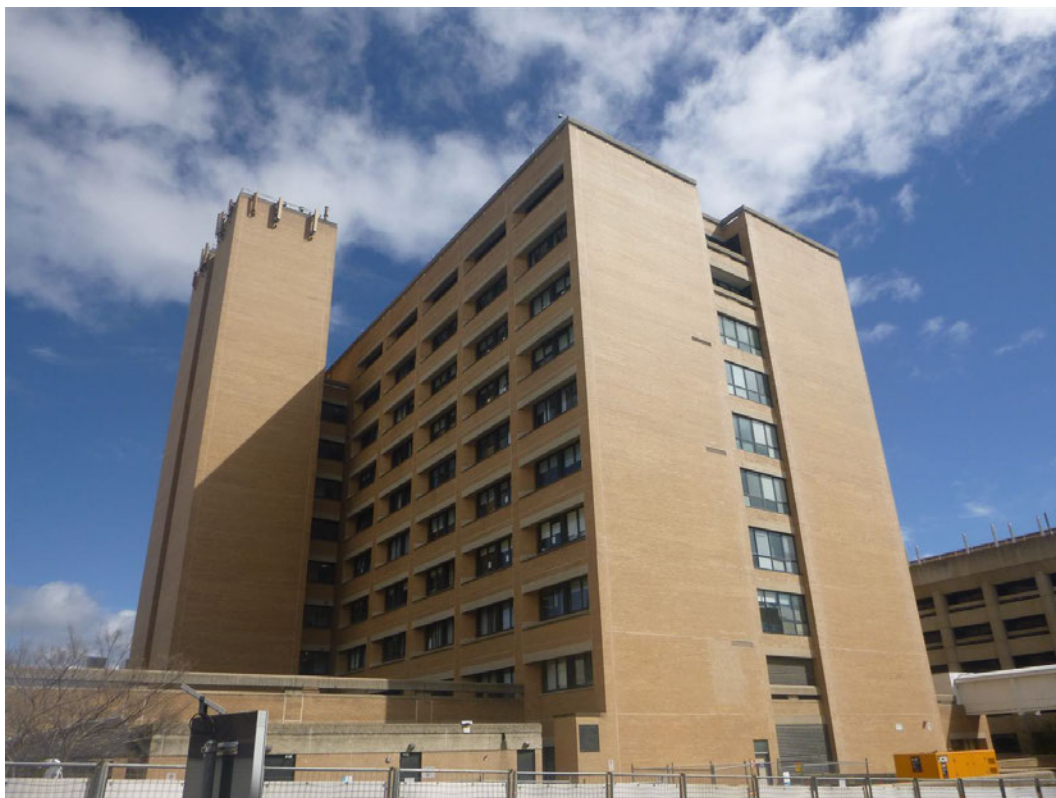
Figure 1: General view of Canberra Hospital's Building 1

The windows generally consist of 'Plasteel' framing and include single glazed panels. This type of window has a PVC sleeve which covers the steel framing elements. It is evident that the windows on the east and west elevation, including the top row of the north elevation, have been replaced with aluminium framed components.

The main roofs consist of a proprietary metal deck system such as 'Kliplok' slopped to a central box gutter. The lift core roof has a membrane with a protective wearing slab.

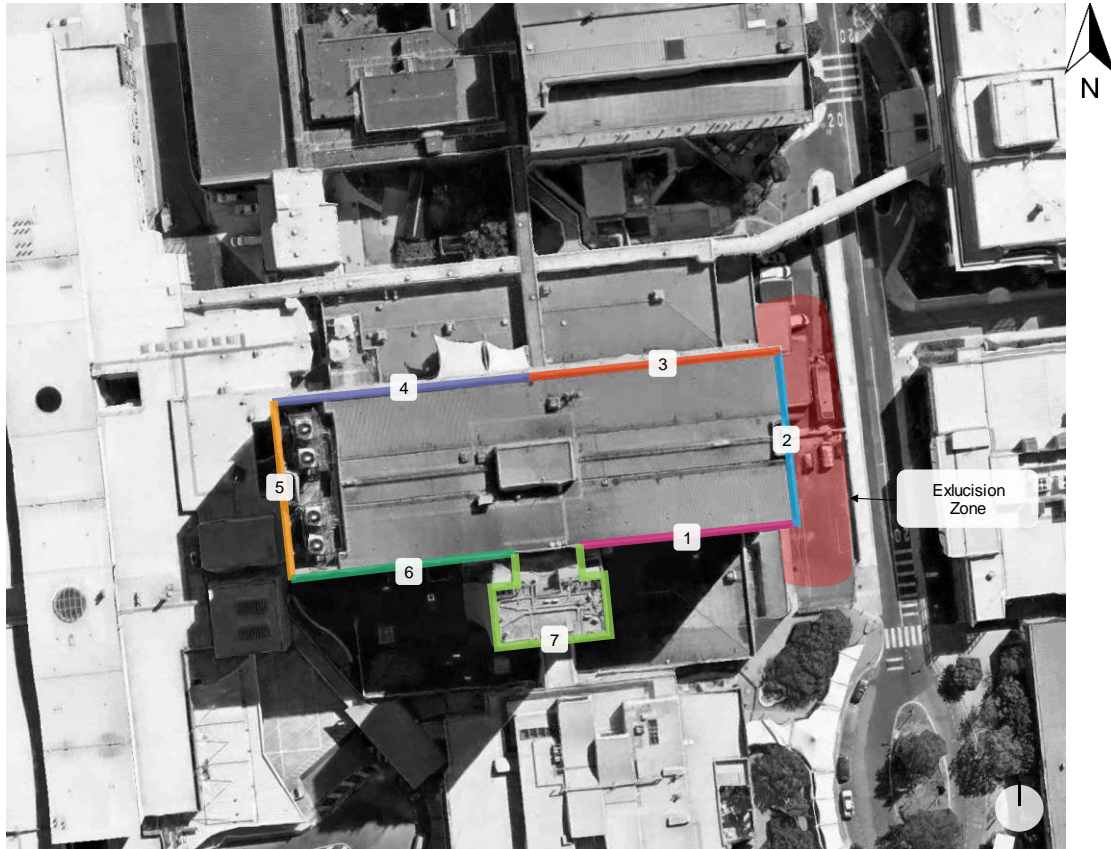
Figure 01. Proposed Staging Plan

Based on our knowledge and the review of conditions report compiled to date we would propose that the façade project be undertaken in total of seven stages. The staging layout provided in Figure 01 has been selected based on the above-mentioned criteria with stage 1 works to be commenced initially. Refer to Figure 02 to 05 for elevations.

We also recommend that prior to any works taking place a detail investigation be undertaken to confirm the cause of façade defects which will in turn allow for a design of site specific remediation strategies.

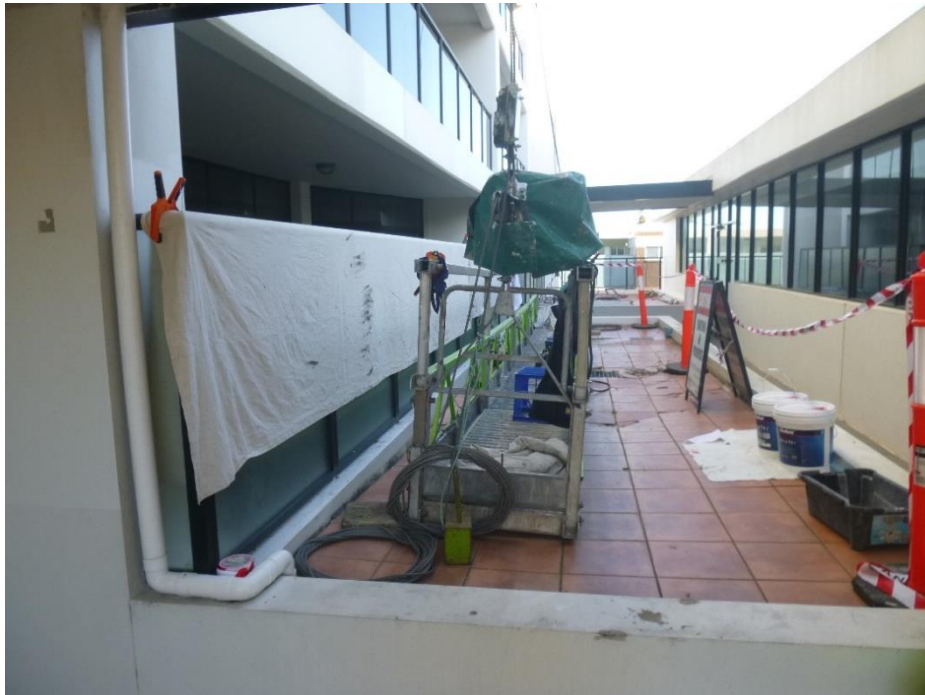
Figure 06. General view of the working platform/cradle.

Swing-stages are light duty suspended scaffold systems that consist of a cradle supported by a row of suspension ropes. The swingstage is connected to two roof mounted cantilevered outriggers. Refer to Figure 06 and 07 for reference.

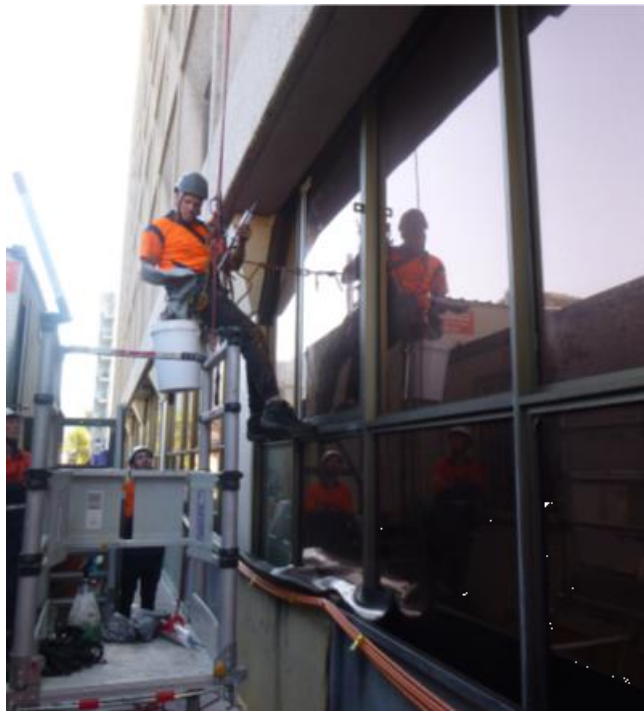
Figure 04. Façade resealing works in progress.

Industrial Rope Access is a specialist service which aims to provide the fastest and most cost-effective façade access method for all kinds of buildings and other structures. It involves gaining access via vertically suspended ropes.

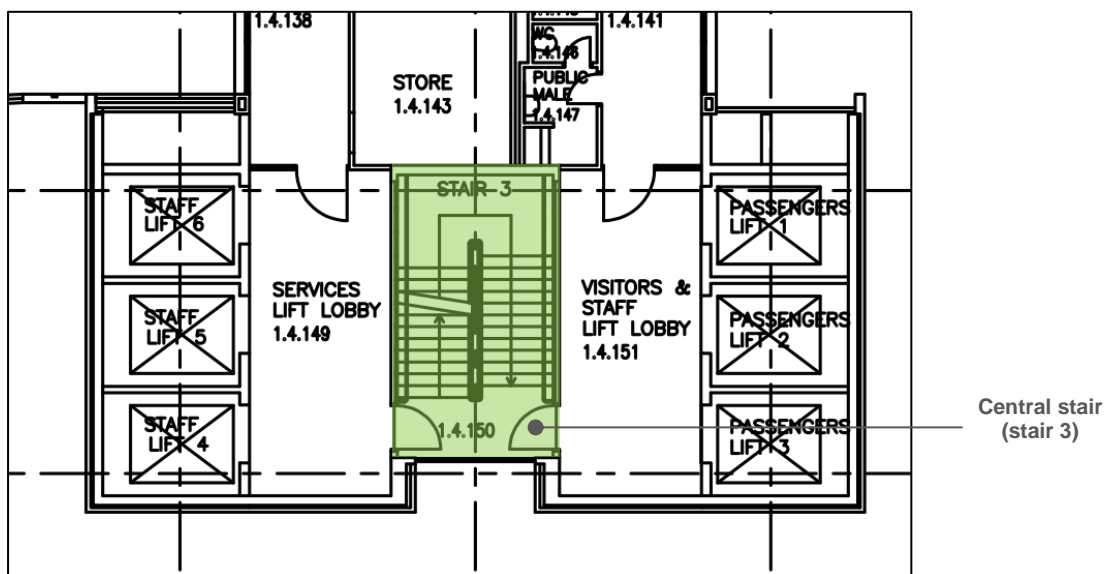
Figure 2 Central stair (stair 3) – typical level

The assessment demonstrates that the risk of fire and smoke spread via the central stair 3 on levels 2 to 10 is mitigated equivalent to a fire-isolated stair or fire-rated service shaft. The stair is not considered to represent an undue hazard to occupants evacuating the building. The proposed design of the building is therefore considered to achieve compliance with performance requirements CP2, DP4, DP5 and EP2.2 of the BCA, subject to compliance with the fire safety measures given in section 5.

The emergency management plan for the building must be updated to address evacuation procedures for the building when the existing sliding doors on level 2 adjacent to central stair 3 are closed.
