Freedom of information request – FOI18-48

Remedial Action Plan

Former West Belconnen Fire Station

West Belconnen RAP
Remedial Action Plan

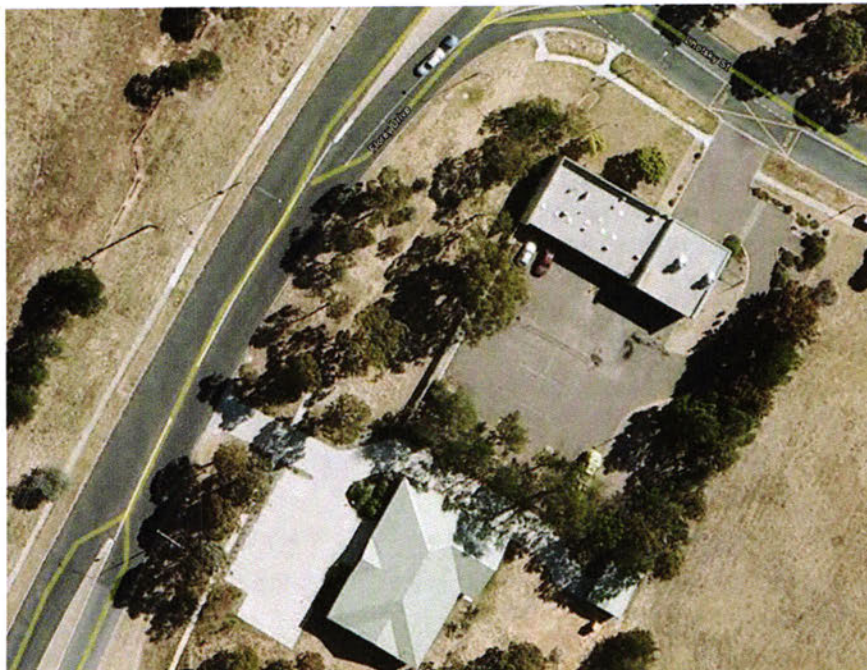
Figure 1 Former West Belconnen Fire Station Site Layout

Figure 1 (below) illustrates the layout of the Site.

Following removal of the identified contamination sources within the Site (USTs, Fuel Dispensers etc.), validation and classification samples are to be collected and analysed to assess the suitability for the proposed ongoing commercial/industrial land use.

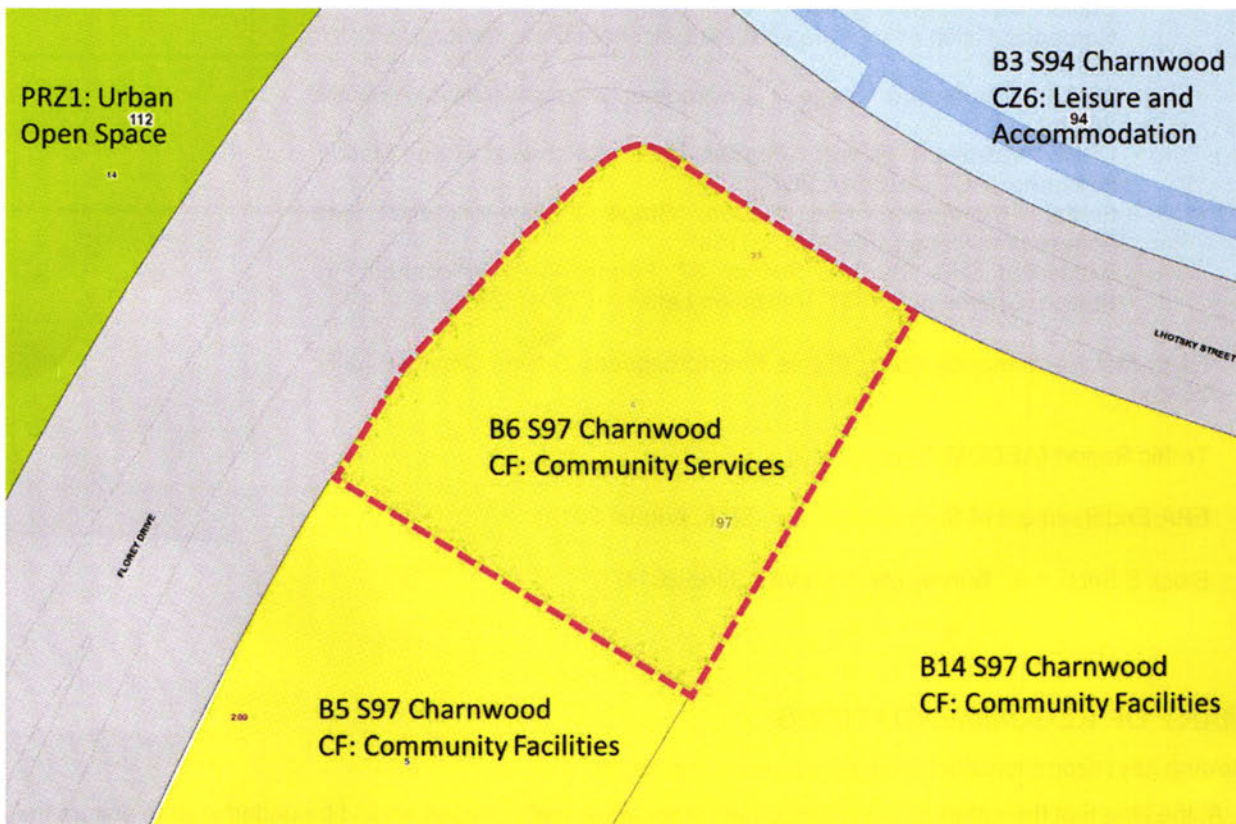
Figure 1: Block 6 Section 97 overlaid with Territory Plan

The site is a former Fire Brigade Depot and is zoned under the ACT Government Territory Plan as CF: Community Facilities and can be utilised for a number of different developments according to the ACT Territory Plan, including but not limited to:

- Business Agency
- Child Care Centre
- Health Facility
- Office
- Place of Worship
- Public Agency
- Retirement Village

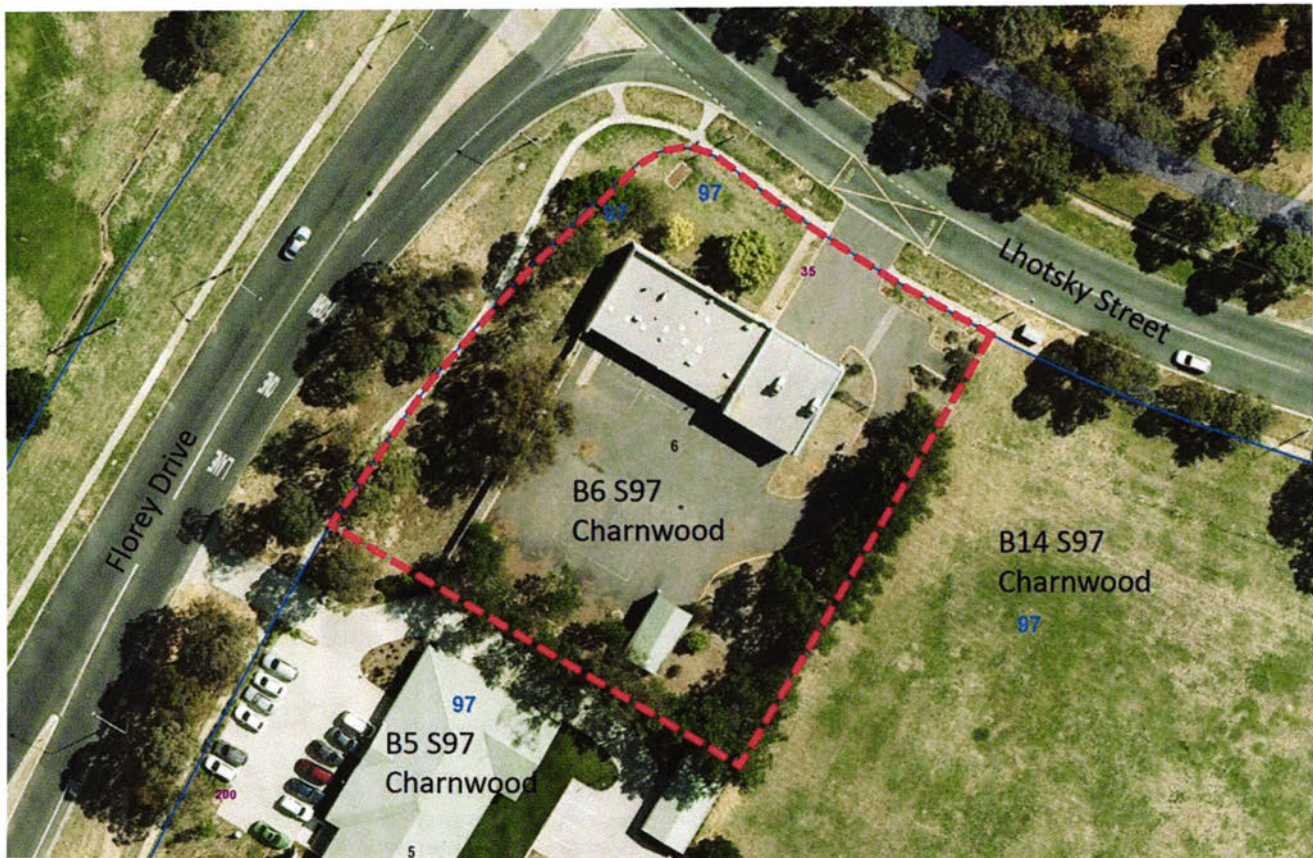
Figure 2: Location of Block 6 Section 97 Charnwood

The site is situated approximately 15km northwest of the Canberra City Centre. The study area is bounded by Florey Drive to the west, Lhotsky Street to the north, with abuttal to the Ginninderra Christian Church (Block 5 Section 97) to the south and St Thomas Aquinas Primary School (Block 14 Section 97) to the east (refer to Figure 2). Currently access to the site is provided via Lhotsky Street.

The site has an area of approximately 3,600 square meters. The site is located on the high point of Section 97. The site survey shows that there are two localised low points located within the bitumen carpark in the southern portion of the site.
