## 6.0 Site Suitability Status

# Remedial Action Plan

Former West Belconnen Fire Station

Stage 1 Environmental Assessment

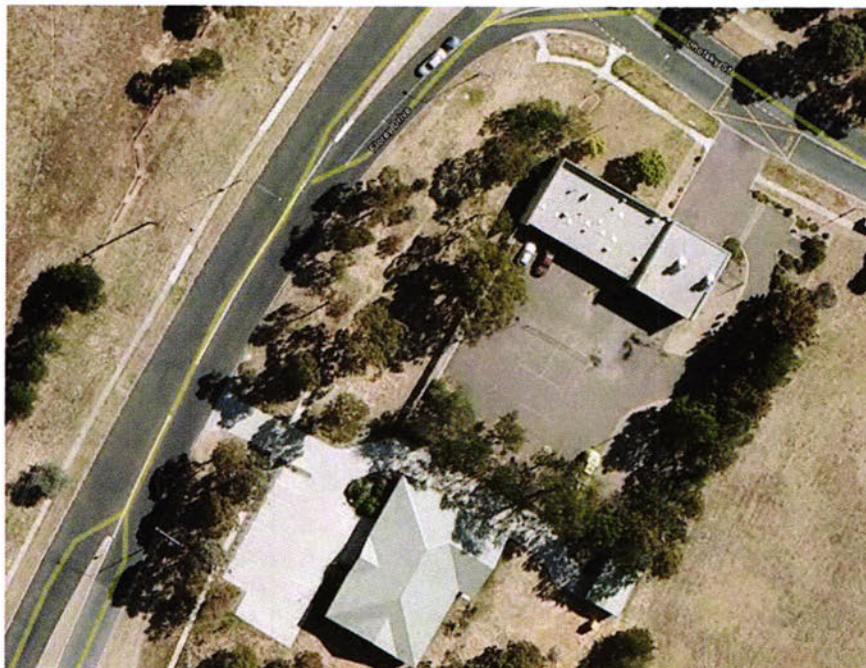
**Figure 1** Former West Belconnen Fire Station Site Layout

A review of site plans provided to AECOM indicates that the storage and dispensing infrastructure is comprised of the following:

- 3 Underground storage tanks up to 4500 L in size. The tanks were identified to contain a range of diesel and petroleum products
- 2 fuel dispensers located on concrete hardstand
- 3 vent pipes
- Buried connective pipework.

**Figure 1** (below) illustrates the layout of the Site.

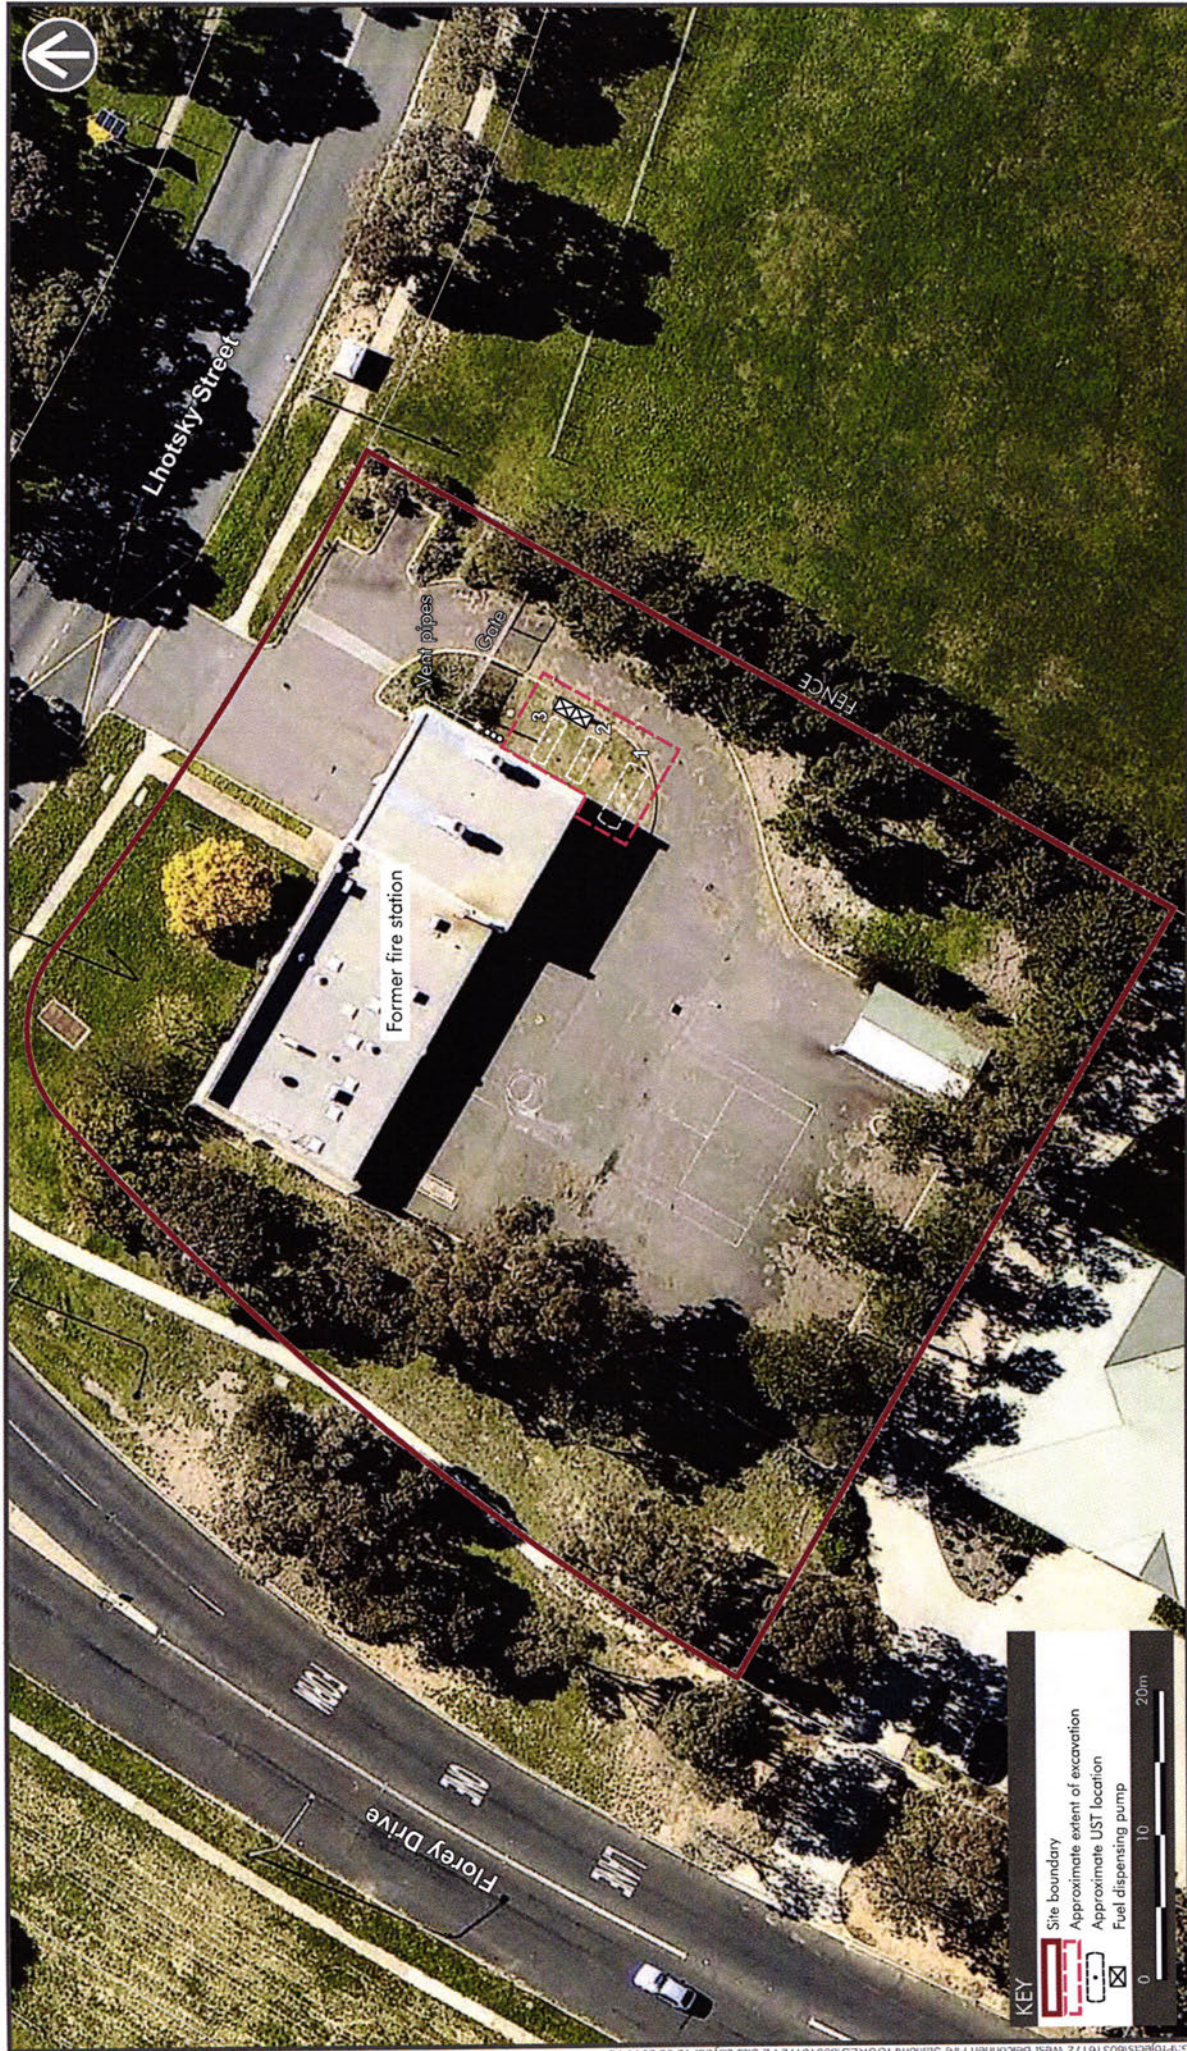
FIGURE 2

**SITE LAYOUT**  
 Former West Belconnen Fire Station  
 Block 6, Section 97  
 Charnwood, ACT

Based on information provided to AECOM by JACs the following table summarises the remediation areas to be addressed. The remediation areas are shown on **Figure 2 (Appendix A)**:

Area(s)	Location	Remediation Extent
1	3 x Underground Storage Tanks located within the eastern portion of the Site adjacent to the site access driveway.	Vertically to approximately 0.5 m beneath the current base of the USTs and laterally as far as necessary and practicable to remove hydrocarbon impacted soils.
2	Vent pipes, Connective pipework and dispensing infrastructure.	Removal of fuel lines, dispensing infrastructure and vent lines and excavation of soil beneath the line to approximately 0.5 m beneath lines.
3	Contaminated soils.	Contaminated soils surrounding the UST tank pits are to be excavated to the extent practicable to ensure risk to human health and the environment is acceptable from potential contamination arising from onsite Underground Petroleum Storage Systems (UPSS) infrastructure.

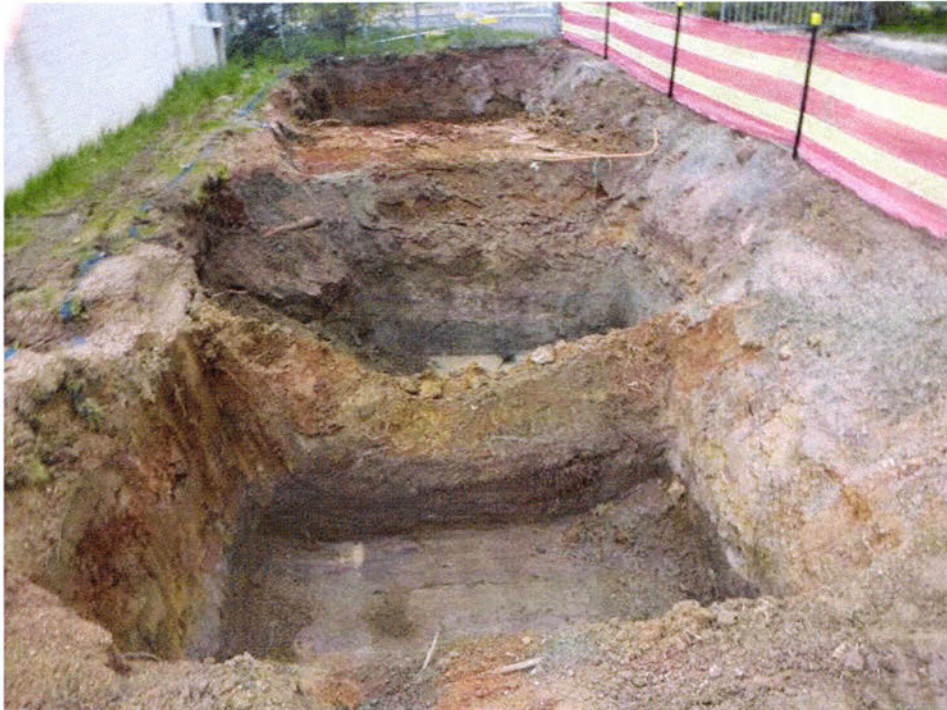
<b>Site Name: Former West Belconnen Fire Station</b>		<b>Site Location: Belconnen, ACT</b>	<b>Project No: 60316172</b>
<b>Plate No.</b> <b>1</b>	<b>Date:</b> <b>26 August 14</b>

<b>Direction Photo Taken:</b> <b>North</b>			
<b>Description:</b> <b>Exposed tank pits</b>

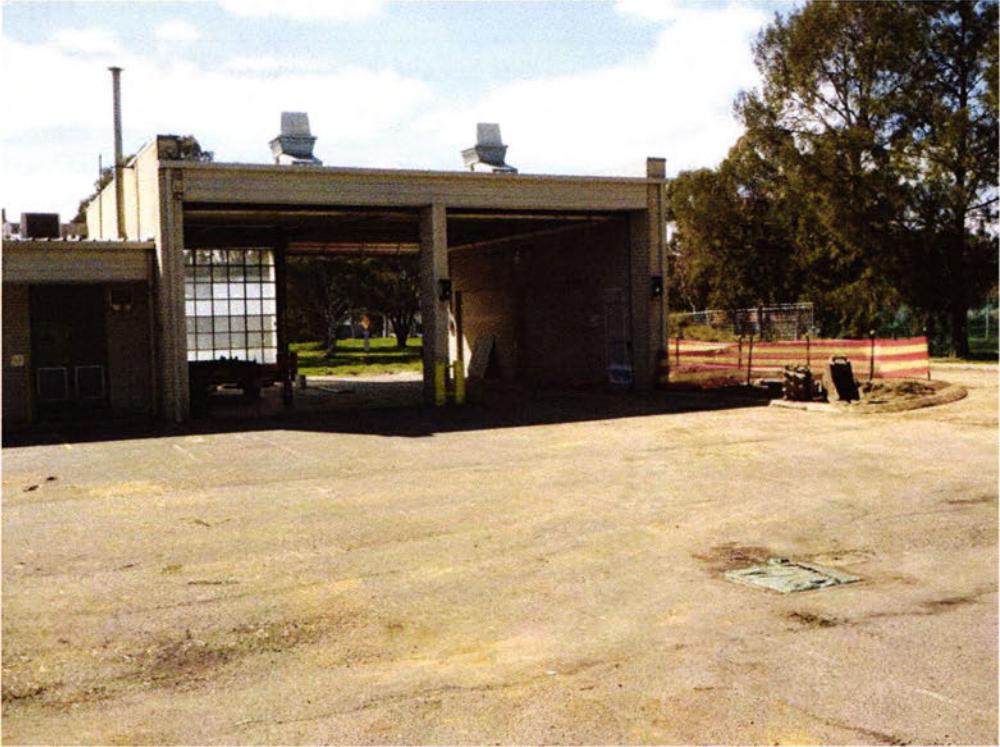
Plate No. <b>3</b>	Date: <b>27 August 14</b>

Direction Photo Taken: <b>North</b>		
Description: <b>From rear car park looking toward the front of the Site</b>

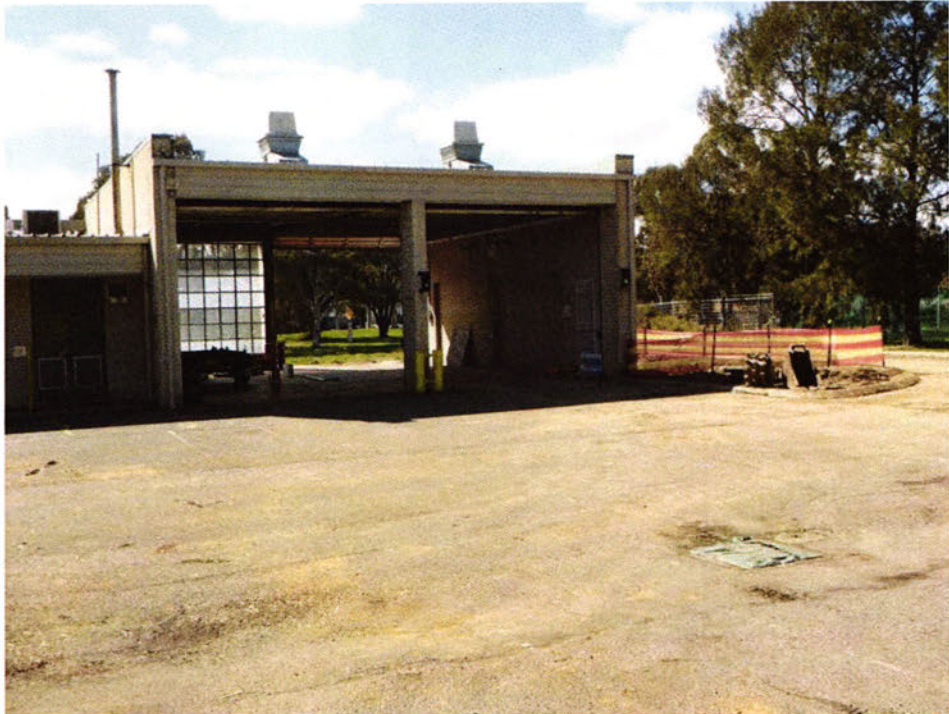
<b>Plate No.</b> <b>6</b>	<b>Date:</b> 27 August 14

<b>Direction Photo Taken:</b> North		
<b>Description:</b> Fire Station Building.
